Appendix F

Structures Visual Inspection Forms

FACILITIES CONDITION ASSESSMENT REPORT

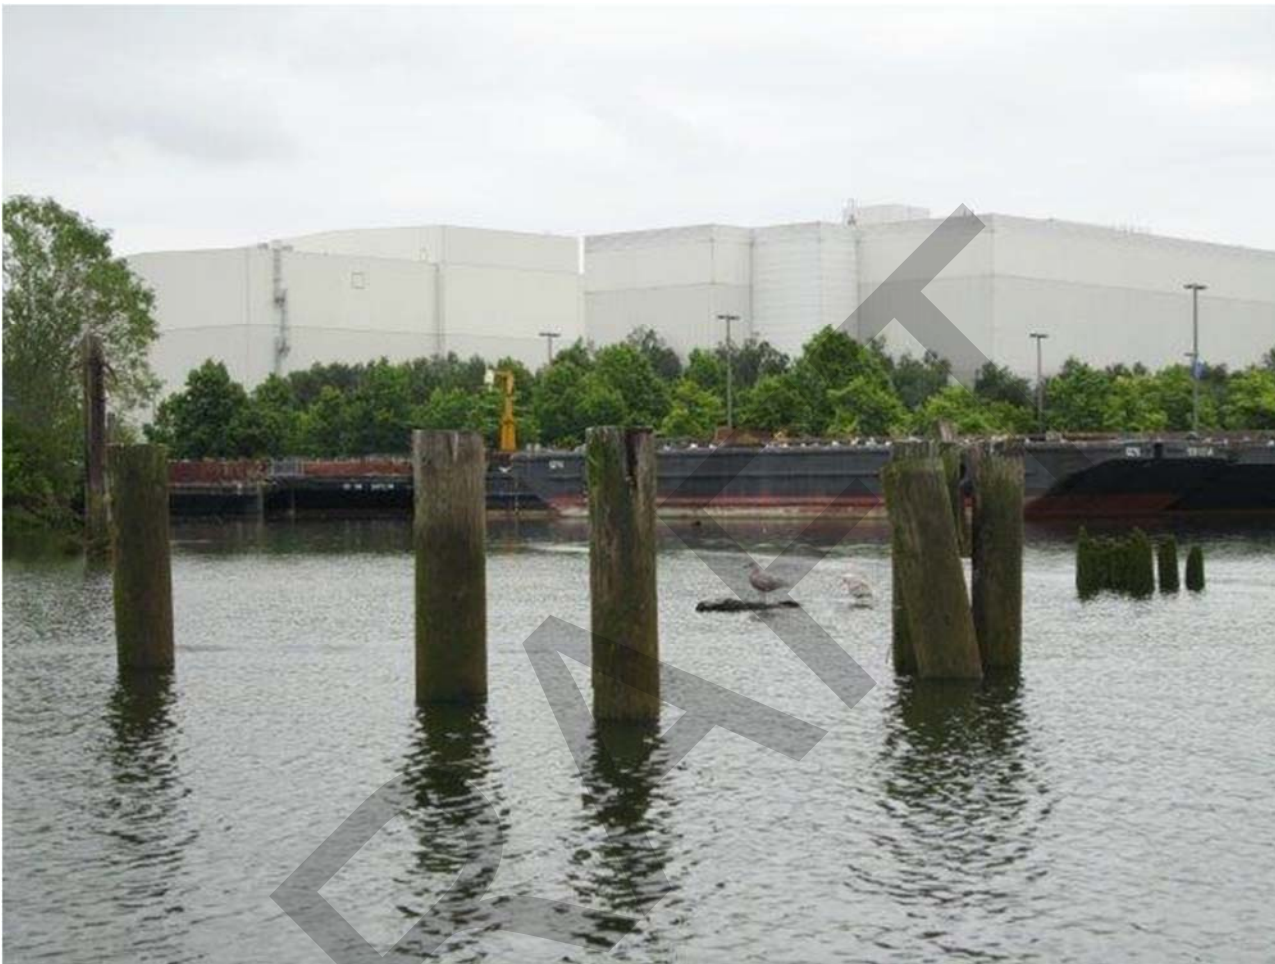
Photo ST41-03: South End of Pier

- L-shaped pier of two (2) timber pile bents – One (1) leg extends west from the shore and the other offshore leg extends to the south.
- The pier is delapidated – Several piles are missing
- Along the south and west side of the pier are several 7-timber pile dolphins. The dolphins are still in use and are missing piles.
- The condition of the piles could not be assessed.

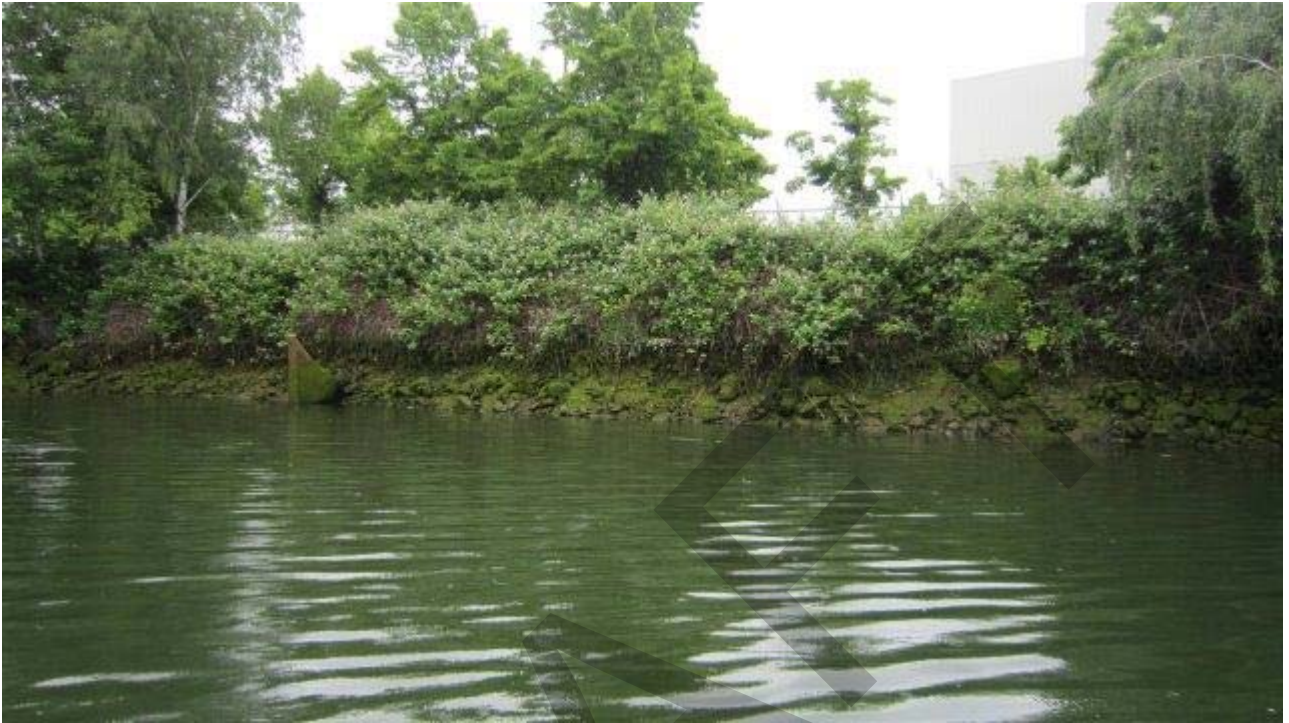
Photo OF10-01: Outfall (Looking North)

- Support stability of pipe overhang is beyond the riprap shoreline.

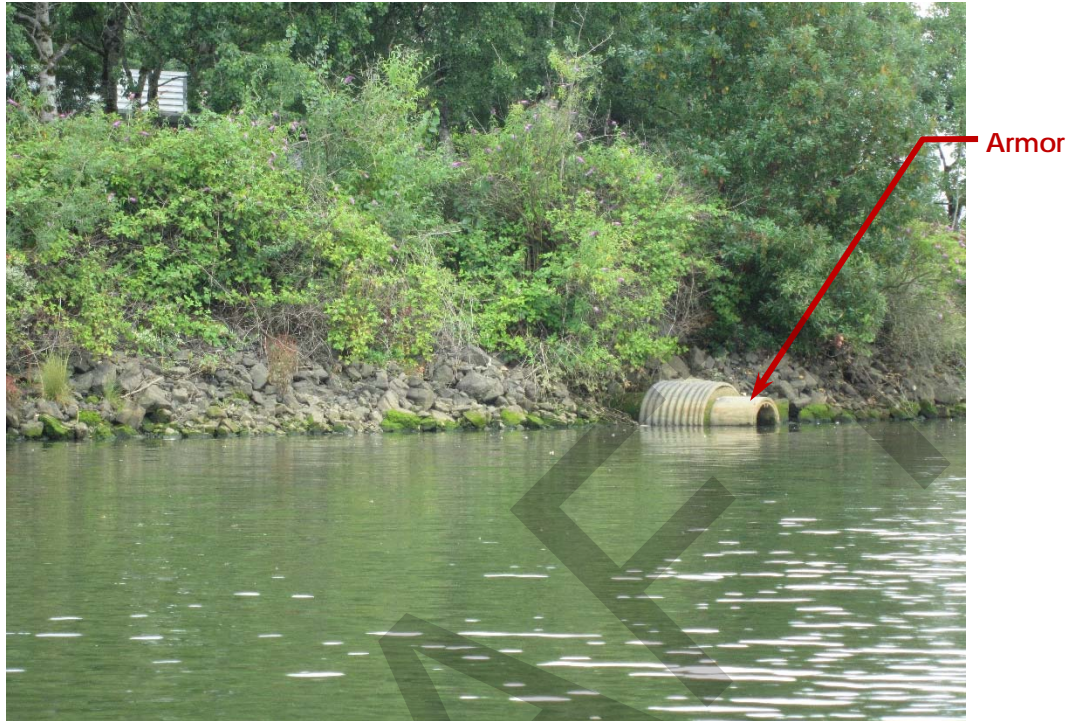
Photo OF12-01: Outfall (Looking Southeast)

- Support of the outfall projection was not observed.

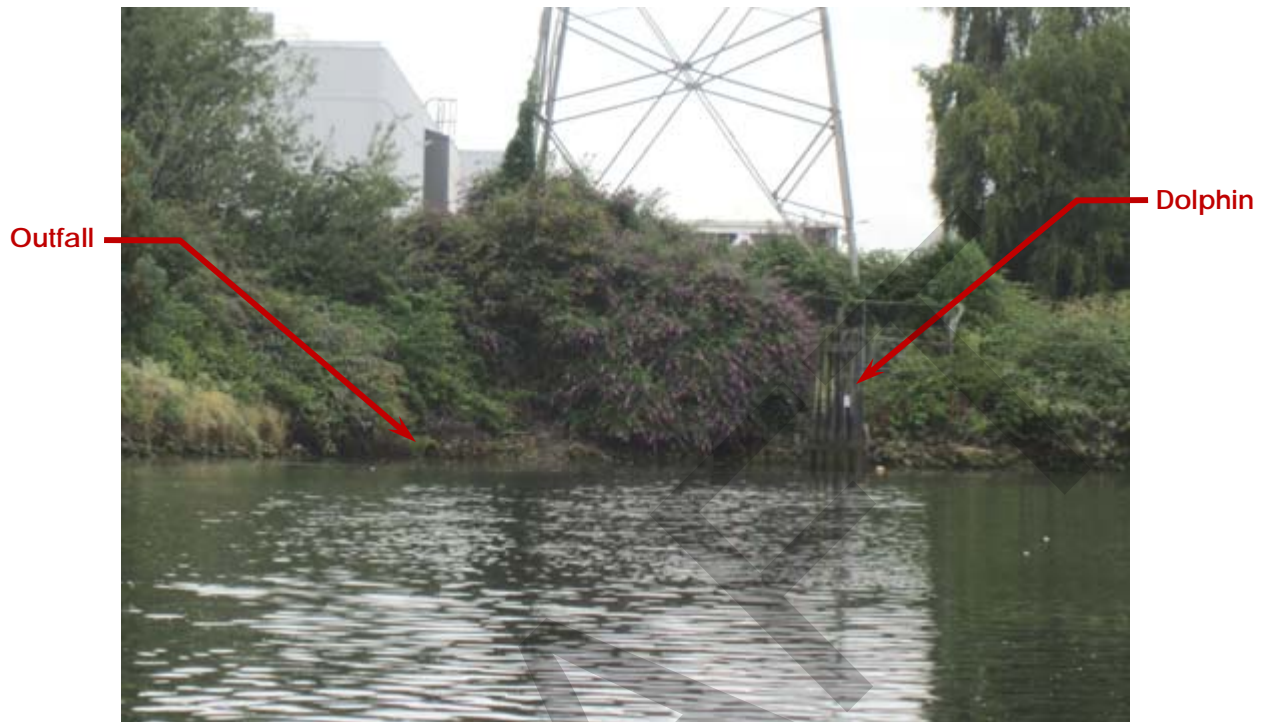
Photo OF13-01: Outfall North of Dolphin (Looking East)

- Support beneath the outfall was not verified.

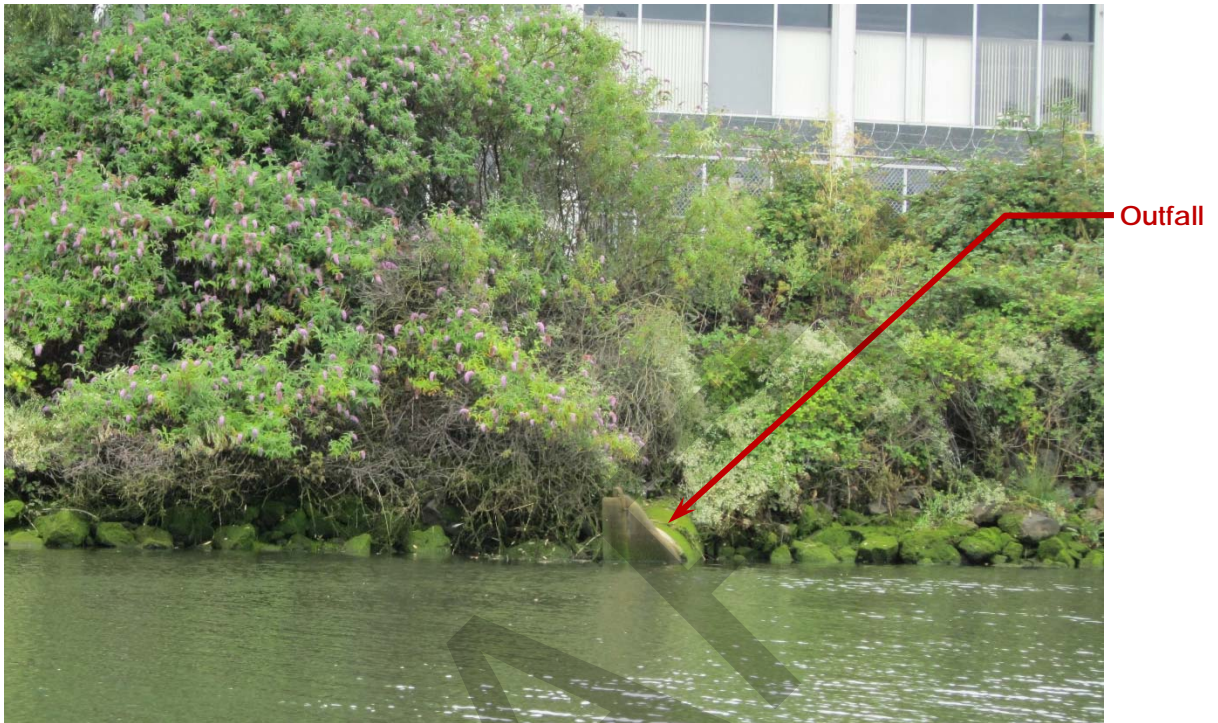
Photo OF16-01: Outfall (Looking East)

- Condition of support beneath the outfall was not be observed.

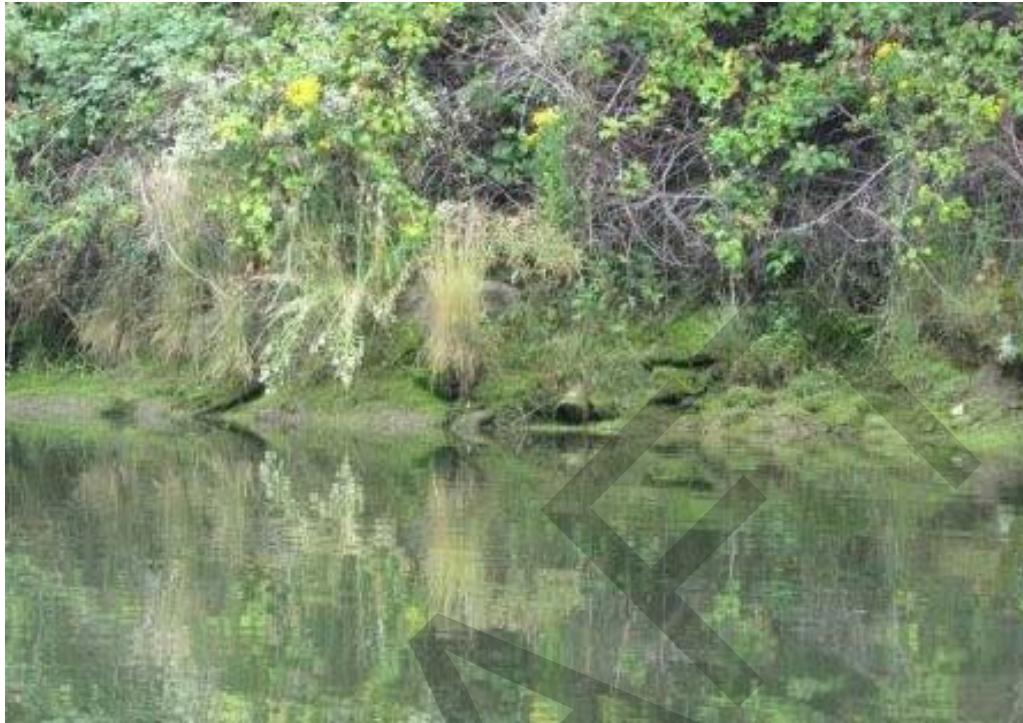
Photo OF18-01: Outfall (Looking East)

- Condition of support beneath the outfall was not be observed.

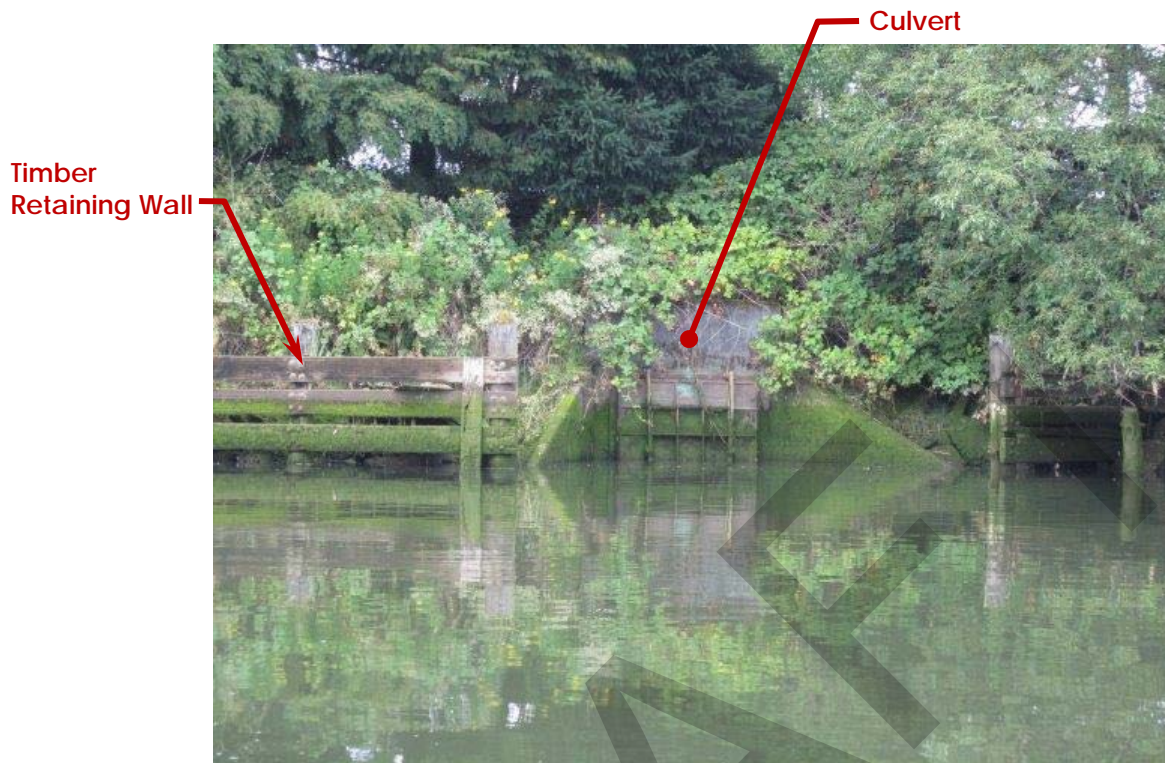
Photo OF19-01: Culvert (Looking East)

- Condition of support beneath the culvert and stability of the retaining walls was not be observed.

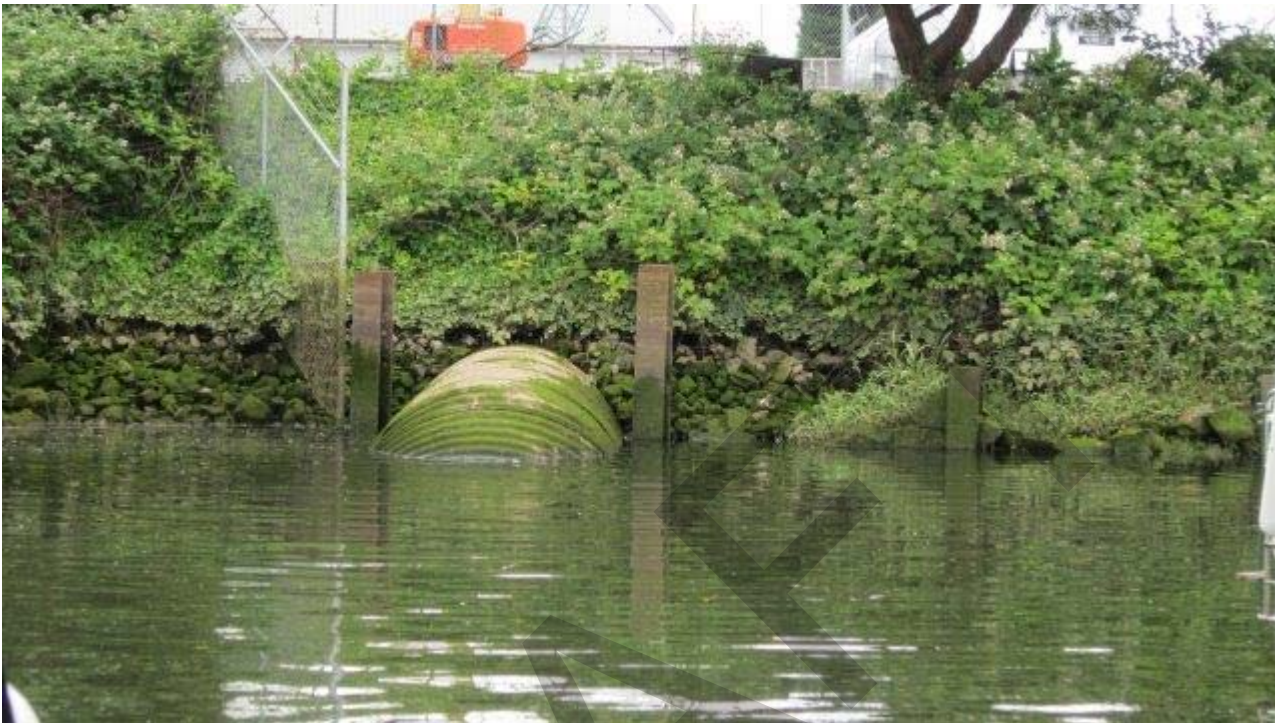
Photo OF22-01: Outfall at Higher Tide Level

- Support beneath the pipe was not observed.
- Adjacent floating decks and guide piles.
